Lessons from the Challenger Launch Decision¹

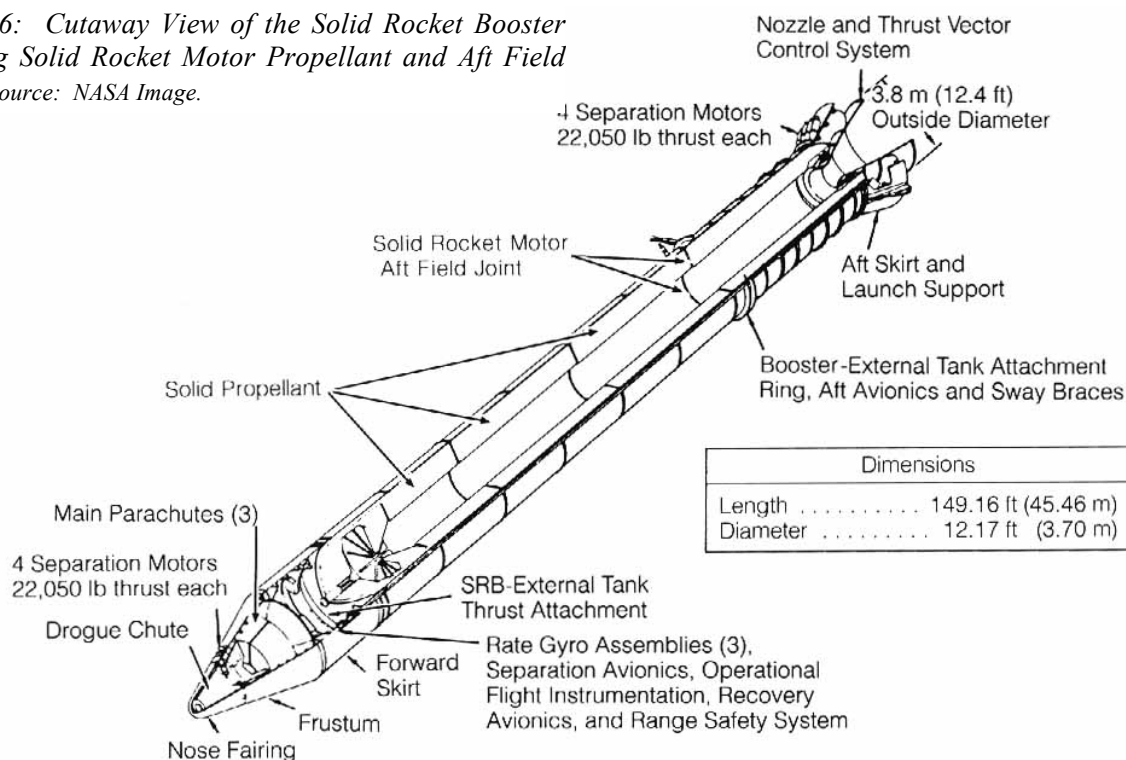
Enhanced photographic and computer-graphic positioning determined that the flame from the right SRB near the aft field joint emanated at about the 305-degree circumferential position. The smoke at lift off appeared in the same general location. Thus, early in the investigation the right SRB aft field joint seal became the prime failure suspect. This supposition was confirmed when the salvage team recovered portions of both sides of the aft joint where a hole had burned through that was 28 by 15 inches. Several possible causes could have resulted in this failure.

very early during the solid rocket motor ignition transient, because the gap between the tang and clevis increased as pressure loads were applied to the joint during ignition. Should pressure actuation be delayed to the extent that the gap has opened considerably, the possibility existed that the rocket's combustion gases would blow by the O-ring and damage or destroy the seals. The principal factor influencing the size of the gap opening was motor pressure; but, gap opening was also influenced by external loads and other joint dynamics. See **Figure 6** and **Figure 7** for images of the SRB.

Figure 6: Cutaway View of the Solid Rocket Booster Showing Solid Rocket Motor Propellant and Aft Field Joint. Source: NASA Image.
